Manhole Inspection Summary

Manhole # S11MM1021MH

Insp Date: **12/6/06 11:37 AM**

Location Address: **3032 ROSALIND AVE**

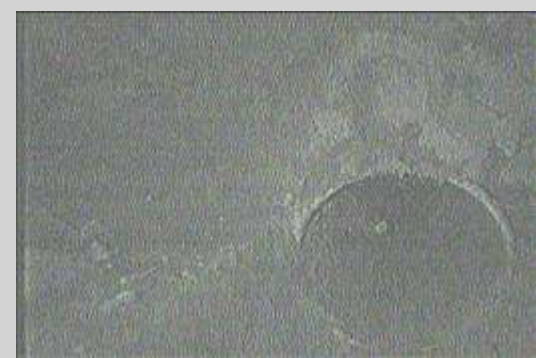
8 in. Circular Gravity Sewer Pipe Out @ 12 O'Clock

Rod and Bar (Angled)

Pipe Material: **Clay** ☐ Pipe Lined

Infiltration: **None** Pipe Seal Cond: **Unknown**
